# **RCRA Subtitle I Inspection Report**

**Sharks Cove Marina**

**Fenwick Island, DE**

**Inspection Date: August 18, 2017**

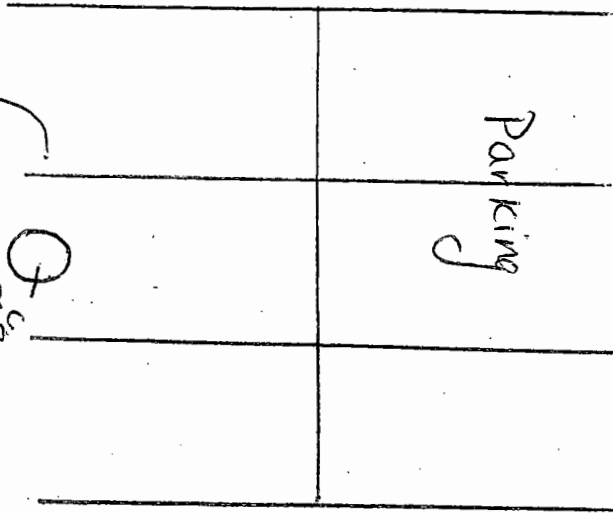
Figure 1: Facility Sketch

Two openings could be observed over the location of UST-001 (see Figure 1). The first opening could not be accessed during the Inspection. A car was parked over the opening for the duration of the Inspection. The Inspector inquired about who the owner of the vehicle was in order to have it moved, however, Mr. and Ms. Juritz were unaware of who was the owner of the vehicle. The second opening corresponded to the tanks automatic line leak detector (LLD) (see Photo #4).

⊗ inaccessible  
due to parked car

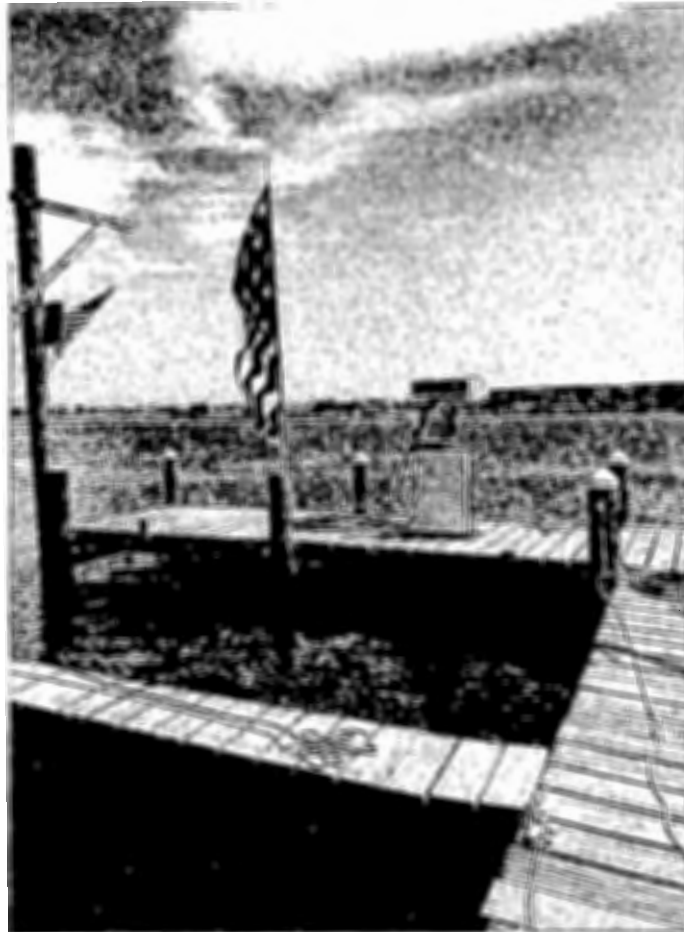
Photo #1: Fueling Pump

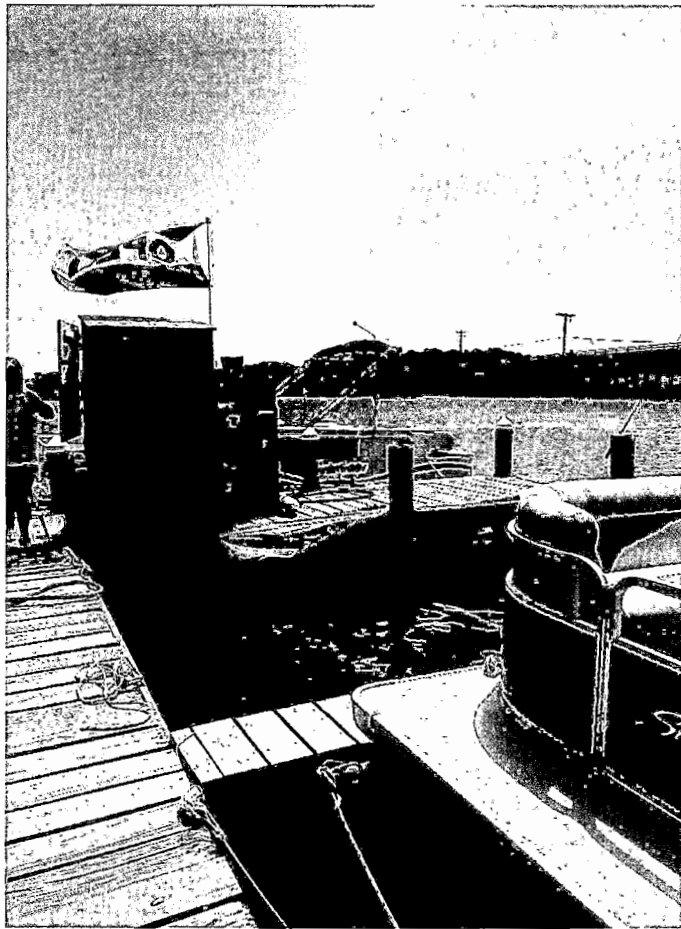
Photo #2: 2<sup>nd</sup> Gasoline Pump

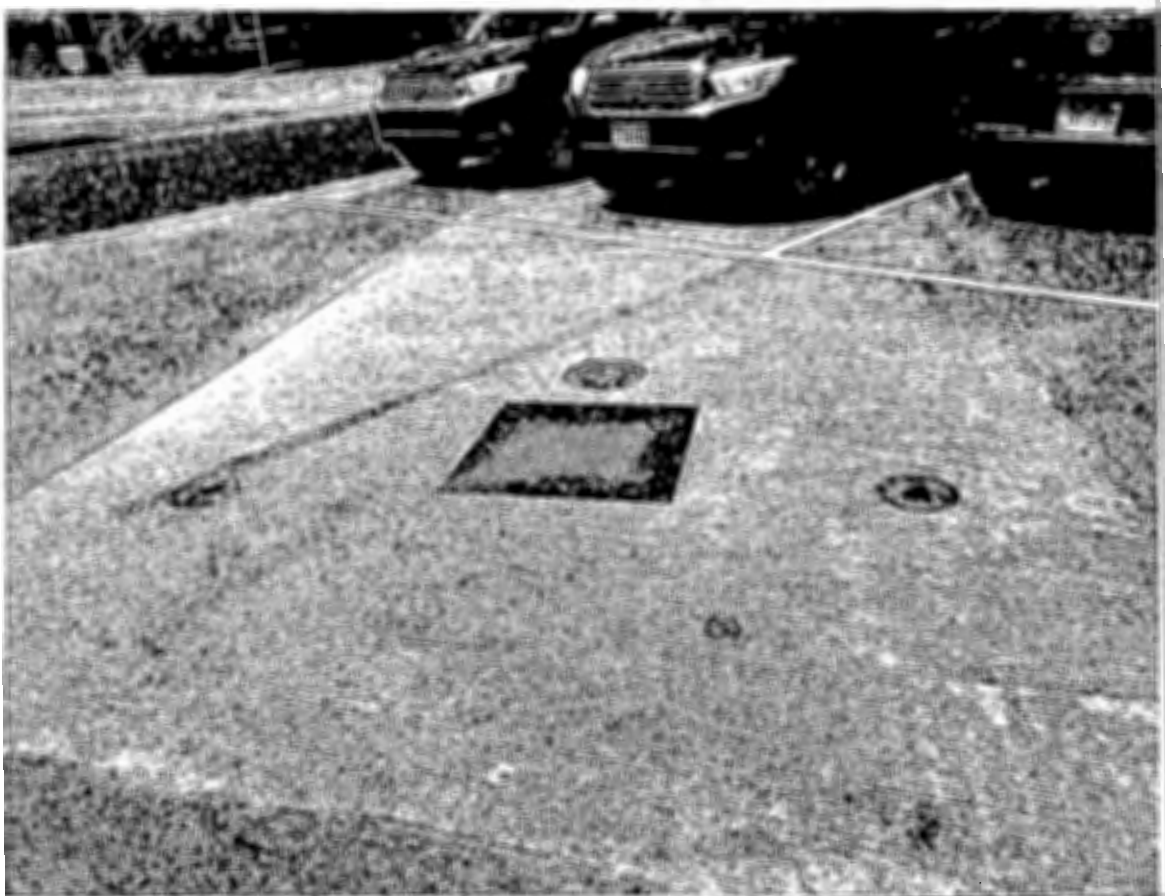
The fill pipe was inaccessible during the inspection, due to an unknown car parked over the cover.

Photo #3: Tank Field depicted one opening visible, and the second opening covered by a vehicle

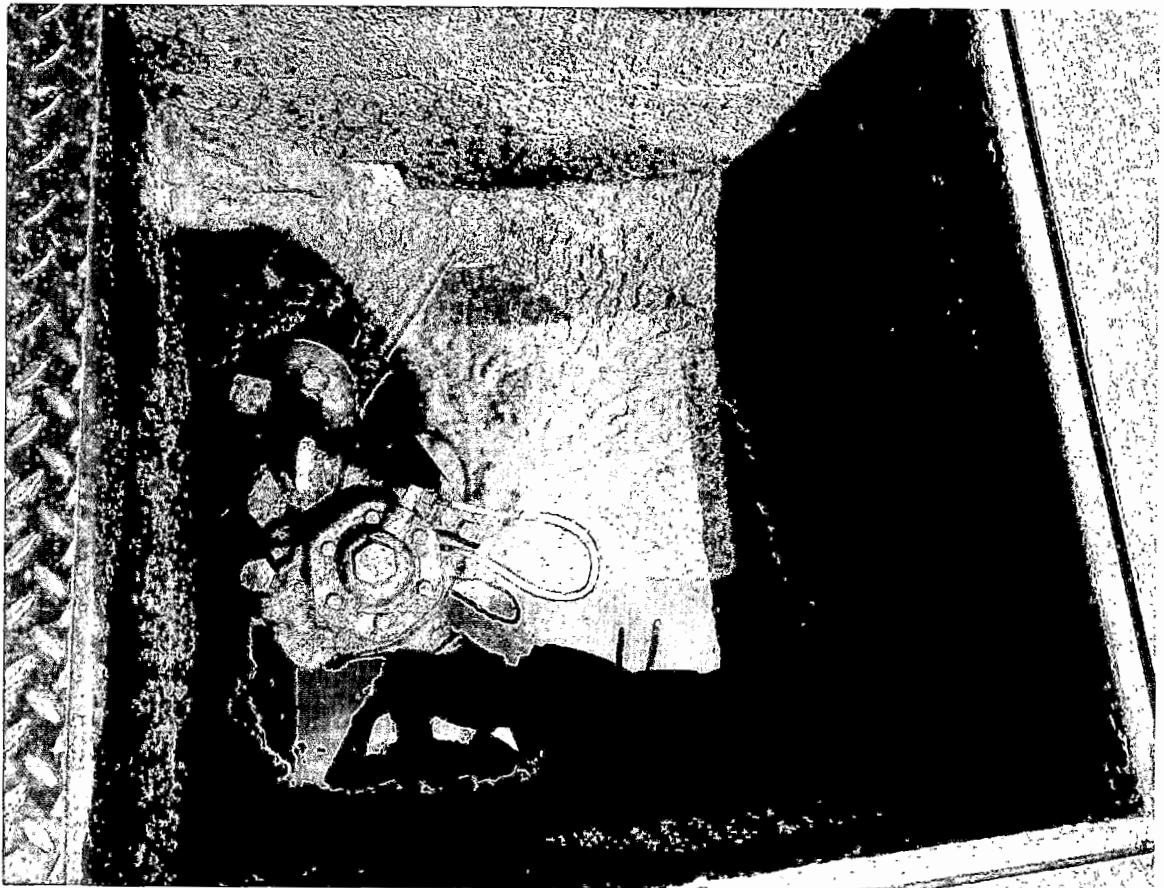
At the time of the Inspection, the fuel transfer line for UST-001 was equipped with an electronic LLD. The Inspector requested the most recent results for line tightness testing and line leak detector testing for the UST. The Facility indicated that these documents are not kept on-site. The Inspector requested from Mr. Juritz that these documents be sent to the Inspector via email. The Inspector did not receive these documents by the time this inspection report was finalized.

Photo #4: Line Leak Detector
